NACA RM E56H06

RESEARCH MEMORANDUM

TURBINE FAILURE INVESTIGATION OF J65-W-4 TURBOJET ENGINE IN AN ALTITUDE TEST CHAMBER

By John E. McAulay, Willis M. Braithwaite, and Carl C. Ciepluch

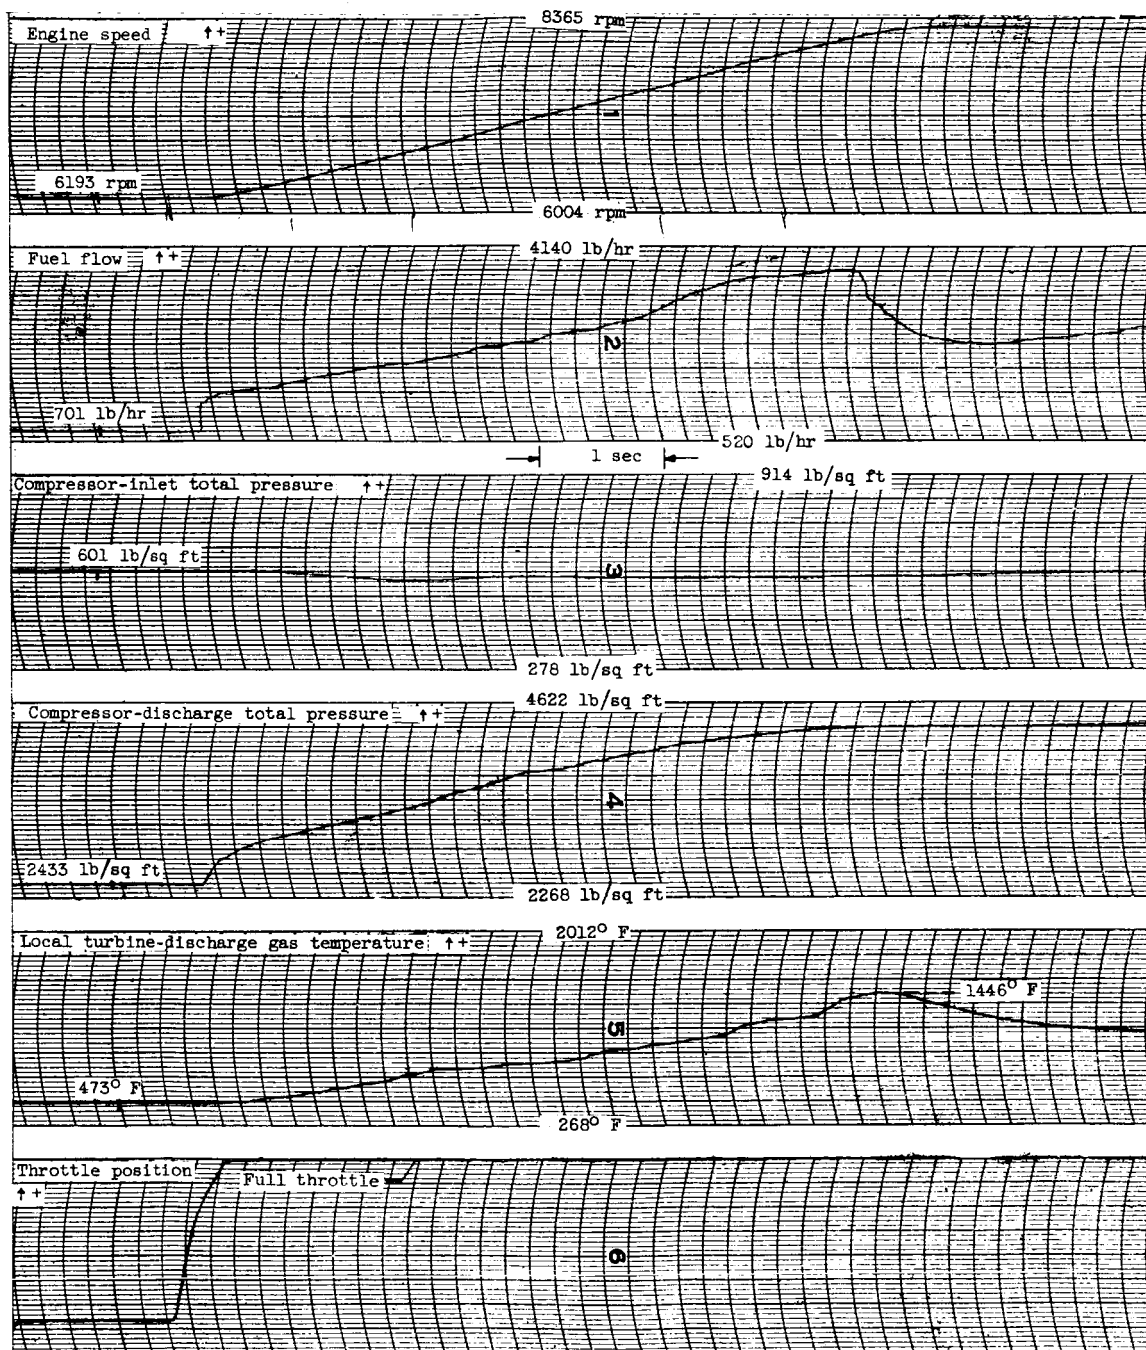
Figure 4. - Typical oscillogram of engine variables during engine acceleration without surge or stall. Altitude, 35,000 feet; flight Mach number, 0.54; inlet-air temperature, -40° F.

Figure 4 shows the engine behavior during a normal acceleration. The throttle was moved rapidly from its part-speed to military rated position. This throttle movement resulted in the fuel control metering fuel flow according to the preset acceleration schedule as qualitatively illustrated below:

Basically, this schedule called for a step in fuel flow from the steady-state operating line toward the compressor stall line; then a ramp increase in fuel flow; and, finally, as rated engine speed is approached, a reduction in fuel flow to the rated steady-state value. Increasing fuel flow from the initial value raised the turbine temperature level and, consequently, the engine speed. This rise in the turbine temperature level and engine speed produced an increase in the

compressor-discharge pressure, which was smooth and continuous for the acceleration shown in figure 4. The maximum indicated turbine-discharge gas temperature obtained during this acceleration was about 1450° F.

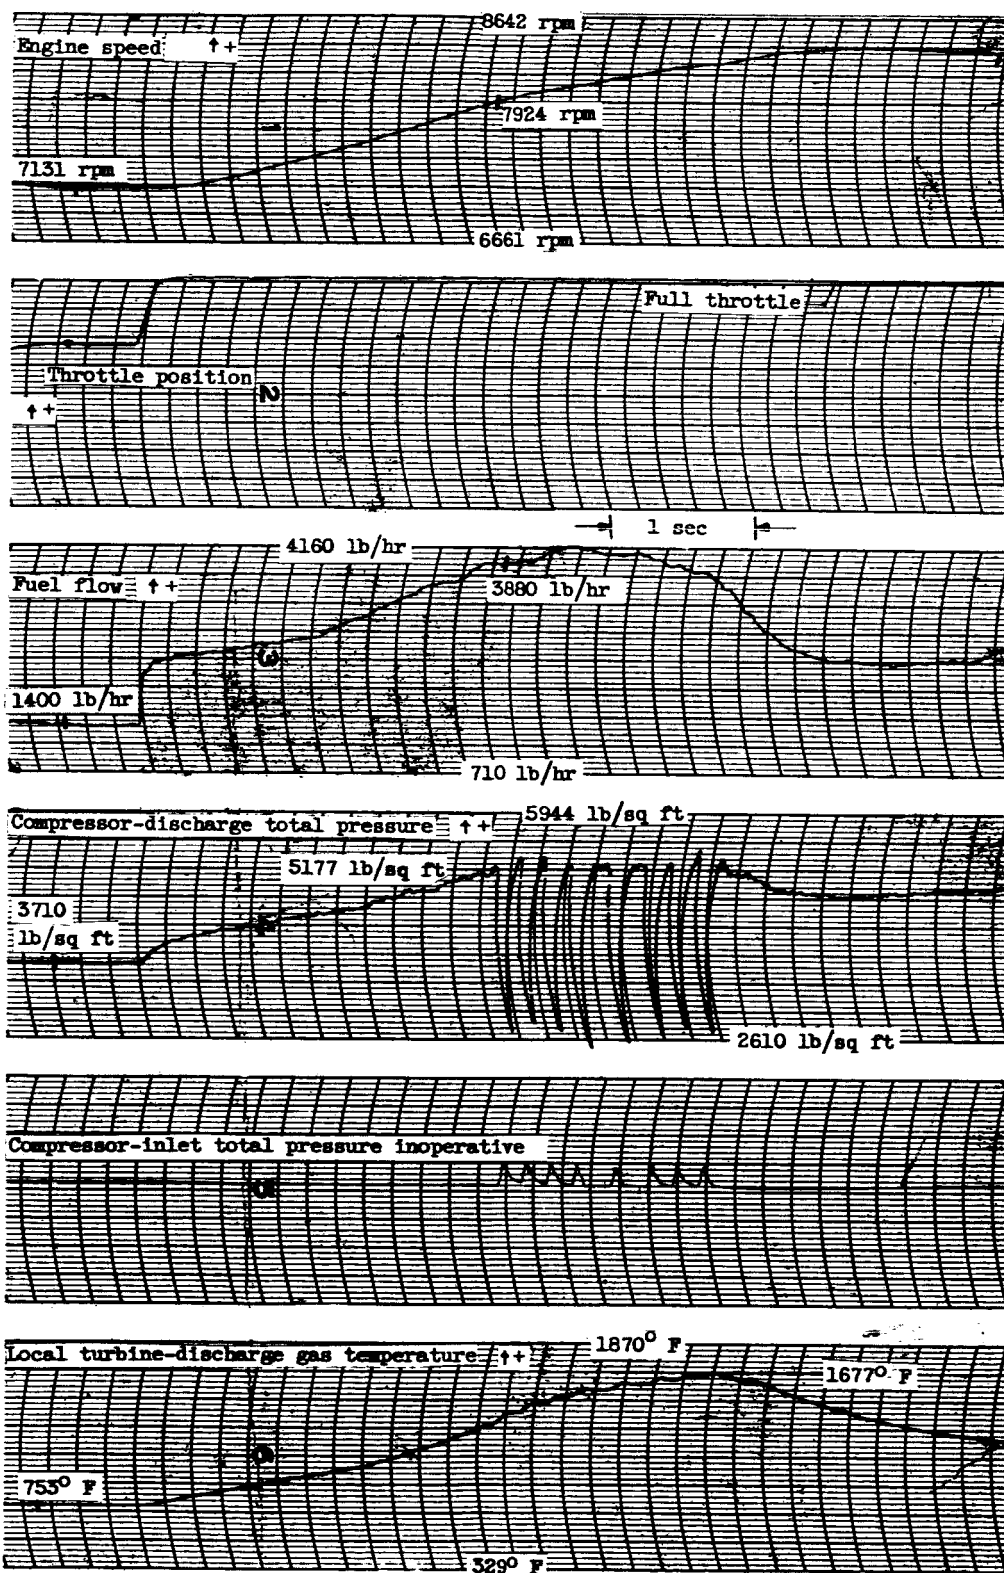
Figure 5. - Typical oscillogram of engine variables during engine acceleration with surge. Altitude, 35,000 feet; flight Mach number, 0.54; inlet-air temperature, -40° F.

The second of the compressor modes of response is presented in figure 5, which portrays an acceleration during which compressor surge occurred. The surge was characterized by one or more cycles of compressor stall and recovery. This acceleration was similar to that shown in the previous figure until, as indicated by the trace of compressor-discharge pressure, the compressor repeatedly stalled and recovered (surged). The surge reduced to some extent the engine acceleration; but, because of its short duration (about 1.6 sec), the turbine blade temperatures did not become excessive. Compressor surge, such as that shown in figure 5, is typical of turbojet engines when the acceleration schedule intersects the compressor stall line at high corrected engine speeds.

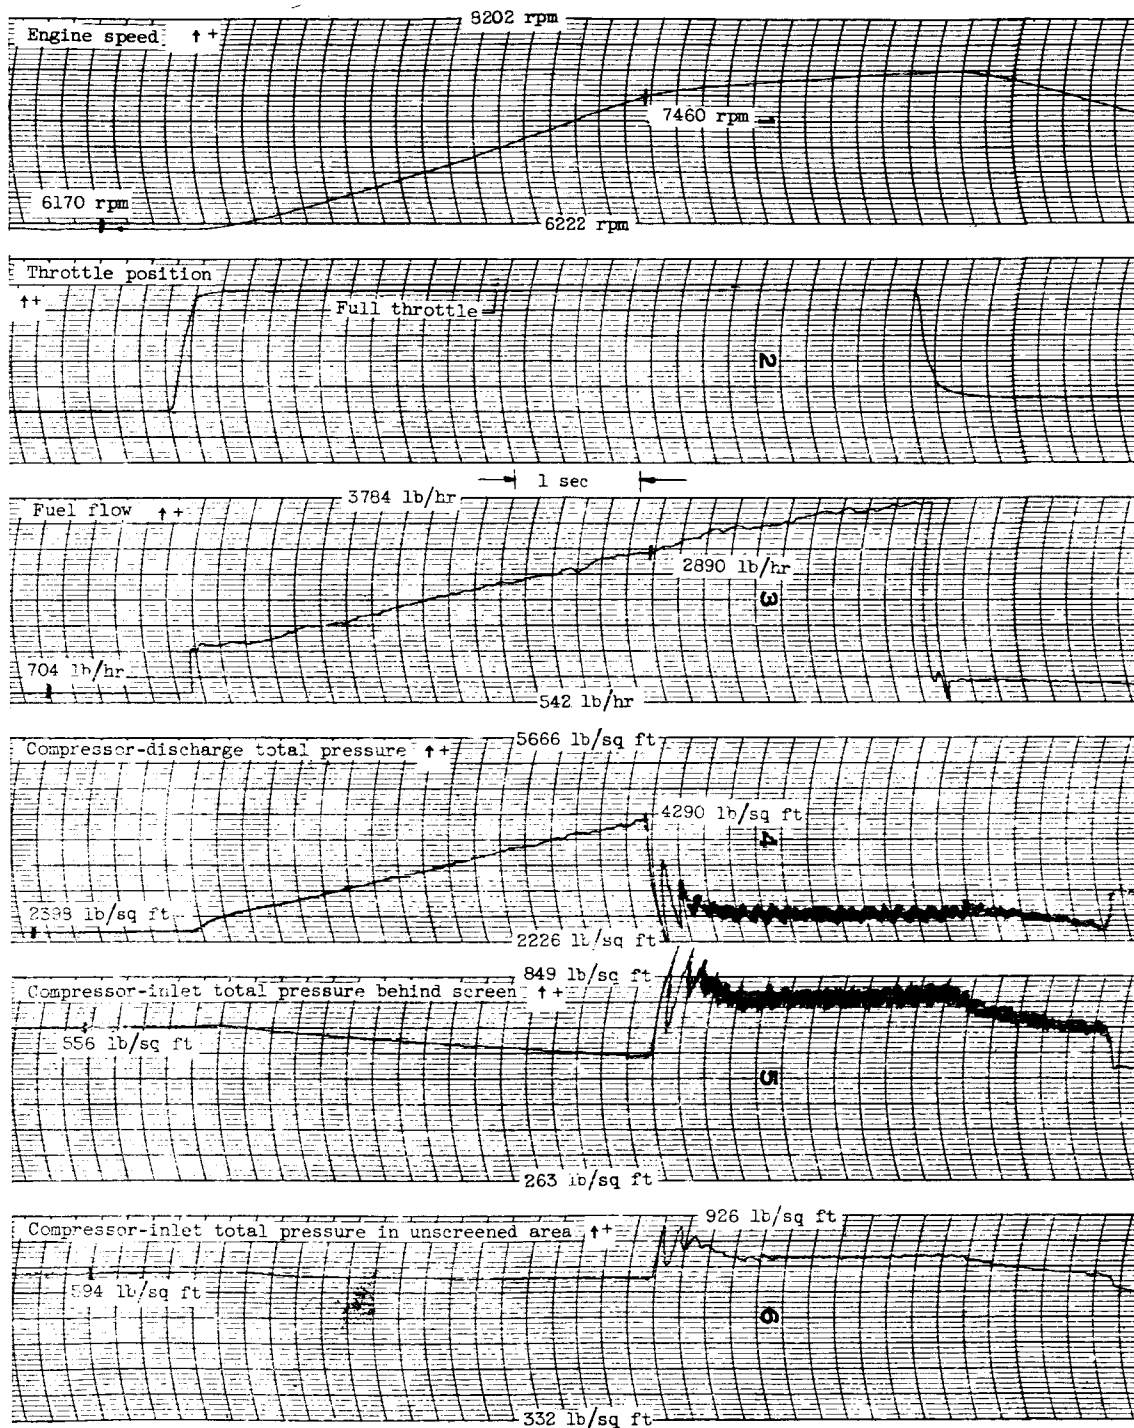
Figure 7. - Typical oscillogram of engine variables during engine acceleration with "hang-up" stall and inlet-air-flow distortion. Altitude, 35,000 feet; flight Mach number, 0.54; inlet-air temperature, -42° F.

Inasmuch as a uniform inlet-air-flow distribution is seldom, if ever, obtained in flight, the effect of inlet-air distortion on the nature of the compressor response to fuel bursts was investigated. Therefore, a method of creating an inlet-air distortion was used to obtain a circumferential distortion of 14 percent (see the section APPARATUS). A typical engine throttle burst at an altitude of 35,000 feet, a Mach number of 0.54, and an inlet-air temperature of -42°F with this inlet pressure distortion is presented in figure 7. During this acceleration, complete compressor stall occurred. The effect that this inlet-air distortion had on the occurrence of surge and stall is presented in the following table:

The data presented in this table show that a 14-percent circumferential distortion greatly increased the occurrence of compressor surge and stall. This trend is expected inasmuch as distortion has the effect of reducing the compressor stall margin (ref. 2). Because the control fuel schedule remained the same for both the distorted and uniform inlet-air-flow cases, accelerations using the engine control and with inlet-air distortion encountered surge or stall at lower corrected engine speeds than those with uniform inlet-air flow. This difference is illustrated by comparing the surge or stall points of figures 5 and 7.

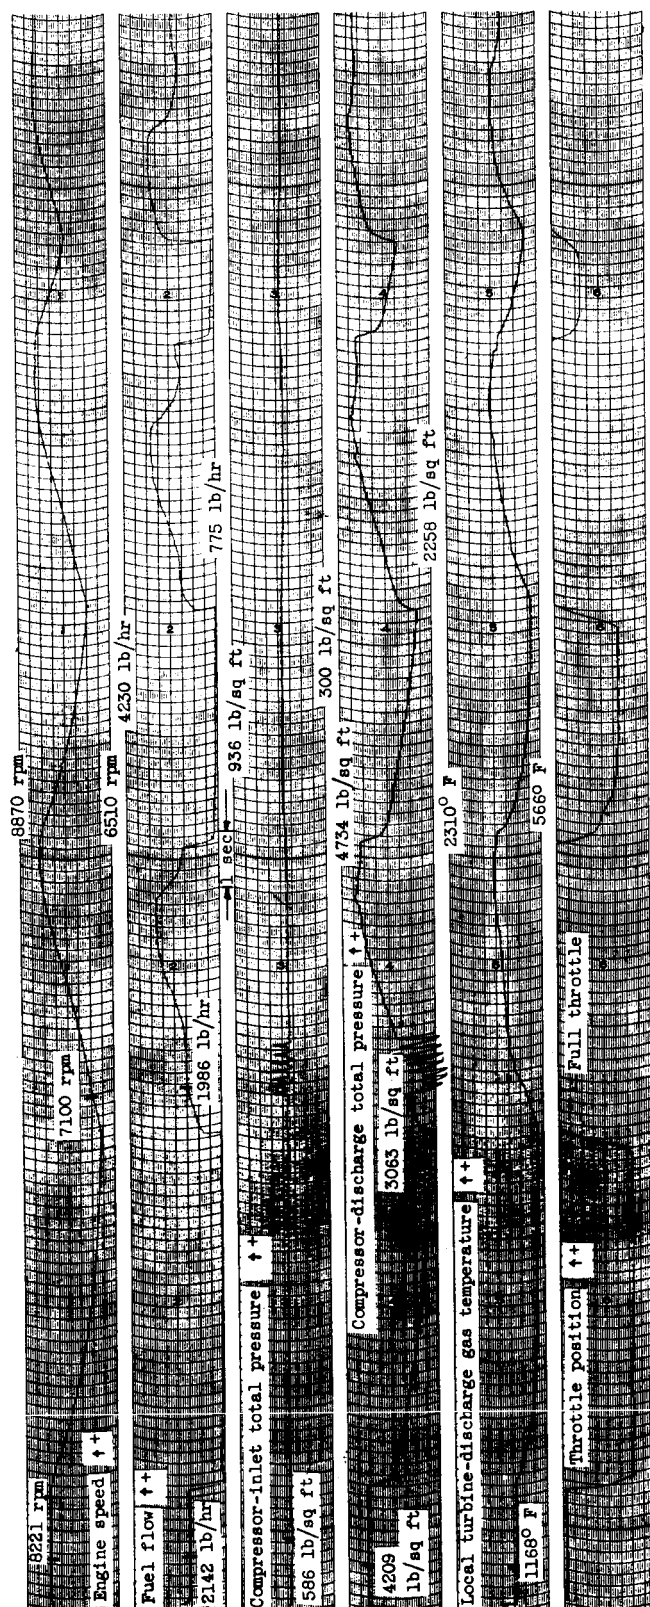
Figure 8. - Wave-off throttle bursts. Altitude, 35,000 feet; flight Mach number, 0.54.

Throttle manipulation which simulates a wave-off-type maneuver, that is, a throttle chop followed quickly by a throttle burst, is also of interest. In figure 8 are presented typical examples of wave-off-type throttle bursts during which surge (fig. 8(a)) and surge and stall

Examination of the data shown in this table and in figure 8 indicates that the results were similar to those obtained with inlet-air distortion, namely, an increase in the occurrence of surge and stall and a reduction in the corrected engine speed at which surge and stall occurred. Comparison of a number of wave-off and single throttle bursts indicated, first, that the fuel schedules for the two types of throttle bursts were the same and, second, that the compressor stall pressure ratio and, consequently, the stall fuel flow were sizably reduced during the wave-off-type throttle bursts. The reason for this reduction is not clear.

(a) Inlet-air temperature, 40° F.

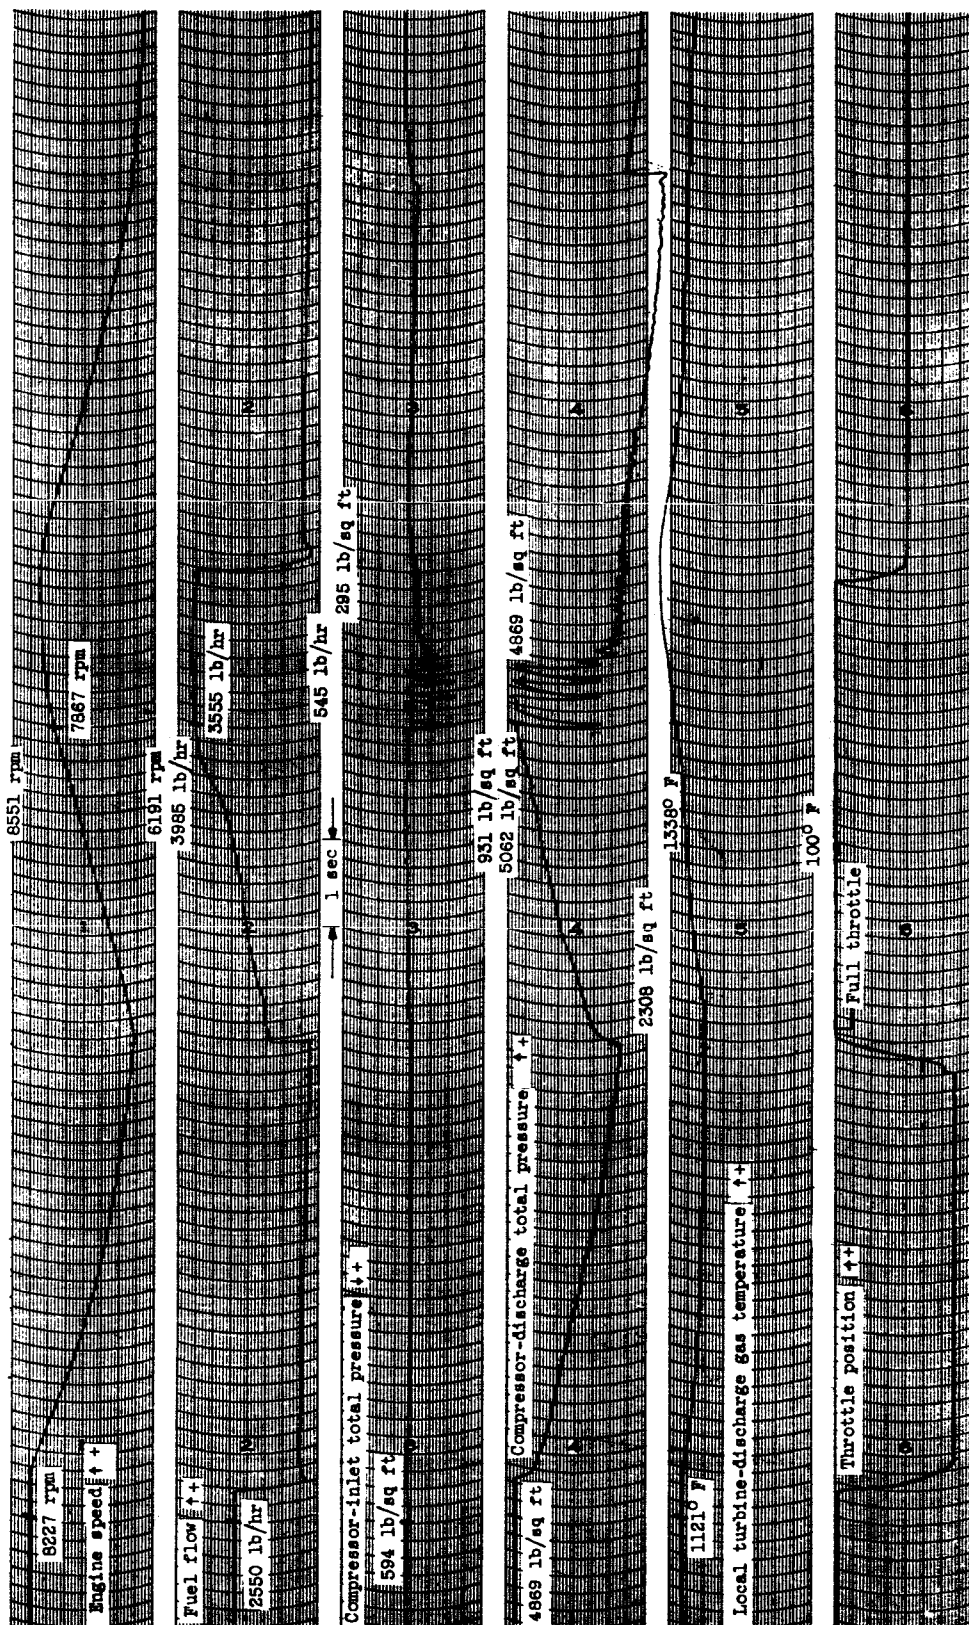
(fig. 8(b)) occurred. The effect of this type of throttle movement on the occurrence of surge and stall is summarized in the following table:

(b) Inlet-air temperature, -45° F.
 Figure 8. - Concluded. Wave-off throttle bursts. Altitude, 35,000 feet; flight Mach number, 0.54.
